## Valtra VT T230 2023

Serial Number **Z230670992**

Inspection date **22 Apr 2026**

Address of the inspection **Aparecida de Goiânia**

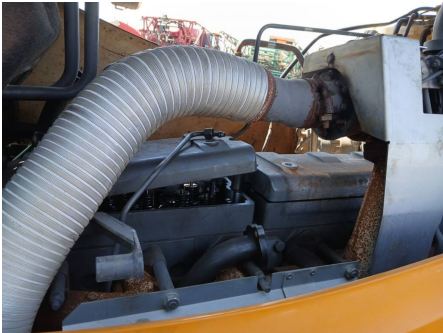
3

| | Value | Note | <div></div> |
|---|---|---|---|
| Engine | | MOTOR COM VESTÍGIOS DE VIOLAÇÃO ALTERNADOR , SISTEMA DE AR E BISCOS DESMONTADOS CHICORTES ELÉTRICOS E PLUGS DESCONECTADOS. | 3, 4, 5 |

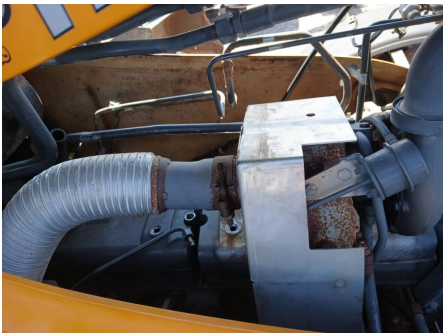
61

| Value | Note | |
|---|---|---|
| Breakdowns (more than 1 if necessary) | EQUIPAMENTO NAO FUNCIONA APRESENTA RISCOS E ARRANHADOS NA PONTURA , PAINEL DESMONTADO E MODOLO DA CABINE COM SINAIS DE VIOLAÇÃO, ALTERNADOR E MOTOR DESMONTADO SACOLA PLÁSTICA COM PEÇAS E AGREGADOS DENTRO DA CABINE BATERIAS RUINS FALTA ANTENA GPS | 61, 62, 63, 64, 65, 66, 67, 68, 69, 70, 71, 72, 73, 74, 75, 76, 77, 78, 79, 80, 81, 82 |
