## Valtra VT T230 2023

Serial Number **Z230670992**

Inspection date **22 Apr 2026**

Address of the inspection **Aparecida de Goiânia**

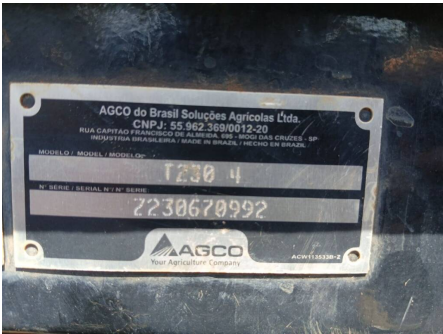
| | Value | Note | |
|---|---|---|---|
| Serial No | | | 1 |

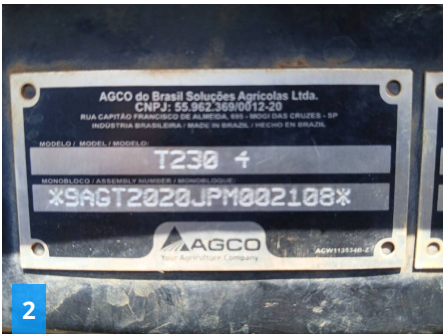
| | Value | Note | |
|---|---|---|---|
| Chassis no | | | 2 |

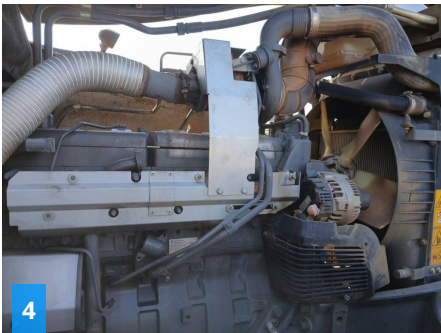
4

| | Value | Note | <div></div> |
|---|---|---|---|
| Engine | | MOTOR COM VESTÍGIOS DE VIOLAÇÃO ALTERNADOR , SISTEMA DE AR E BISCOS DESMONTADOS CHICORTES ELÉTRICOS E PLUGS DESCONECTADOS. | 3, 4, 5 |

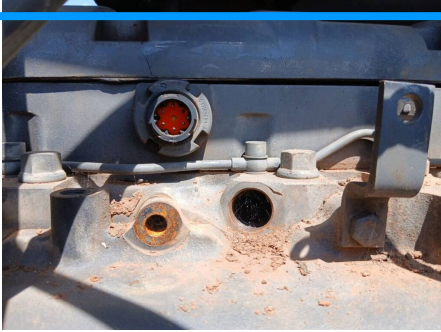
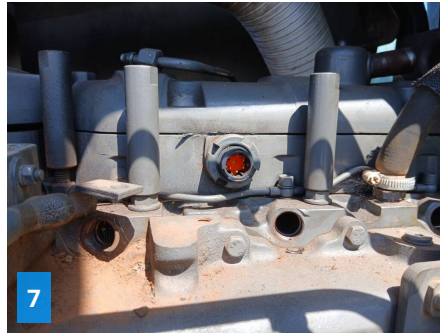
7

| | Value | Note | <div></div> |
|---|---|---|---|
| Pump & Nozzle | | | 6, 7, 8, 9, 10, 11, 12 |

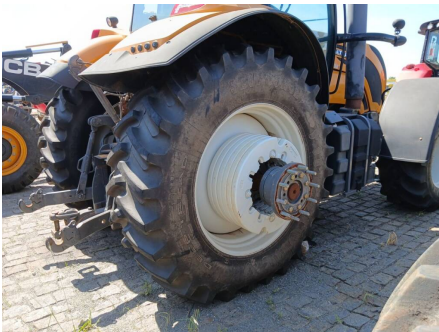
| | Value | Note | |
|---|---|---|---|
| Right Back Tyre | | | 49 |
| Right Back Tyre Condition | Bad | | |

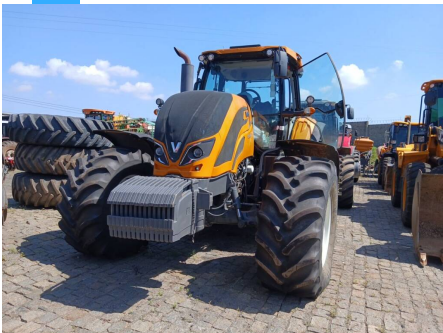
61

| Value | Note | |
|---|---|---|
| Breakdowns (more than 1 if necessary) | EQUIPAMENTO NAO FUNCIONA APRESENTA RISCOS E ARRANHADOS NA PONTURA , PAINEL DESMONTADO E MODOLO DA CABINE COM SINAIS DE VIOLAÇÃO, ALTERNADOR E MOTOR DESMONTADO SACOLA PLÁSTICA COM PEÇAS E AGREGADOS DENTRO DA CABINE BATERIAS RUINS FALTA ANTENA GPS | 61, 62, 63, 64, 65, 66, 67, 68, 69, 70, 71, 72, 73, 74, 75, 76, 77, 78, 79, 80, 81, 82 |
